Home Inspection Report

Assurance Home inspections, LLC
Brian Nabozny
522 26th Avenue East
Ashland, WI 54806
715-292-2707
bnabozny@me.com

Approximate Age: 30 years

Style: Single Family

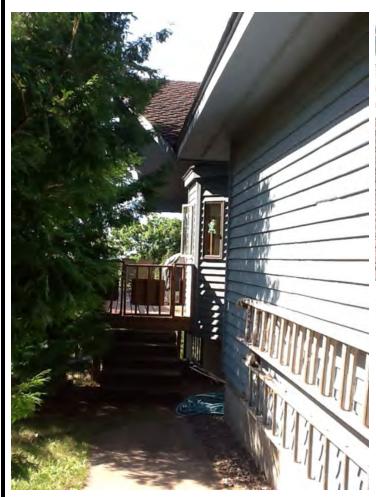
Recommend trimming back tree limbs from exterior to prevent excessive wear.

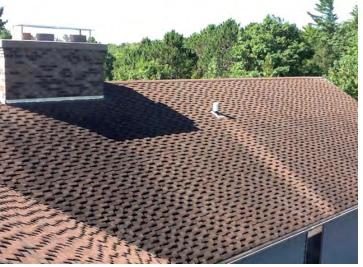
Asphalt architectural roof is showing normal signs of wear due to its age and is in marginal condition.

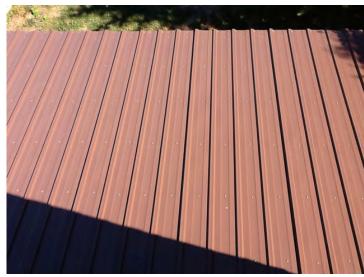
Metal roof over north garage addition was in satisfactory condition at the time of inspection.

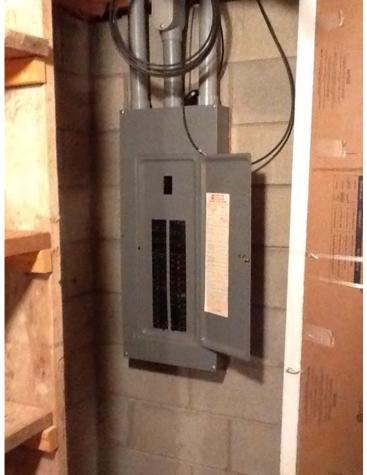
200 amp main electrical panel in basement utility room.

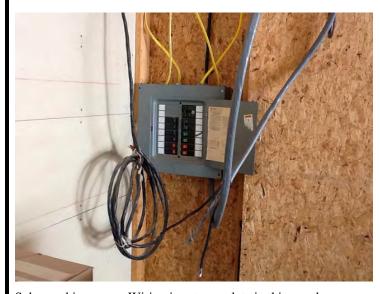
Sub-panel in garage. Wiring is not complete in this panel.

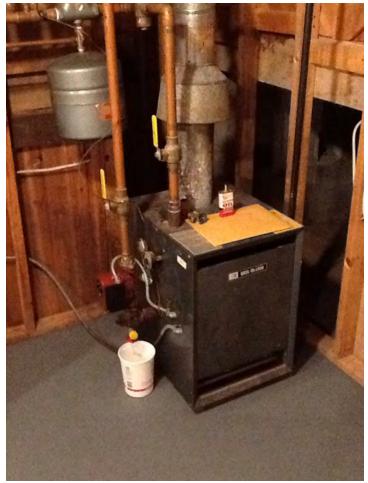
Weil-McLain boiler was in proper working order at time of inspection.

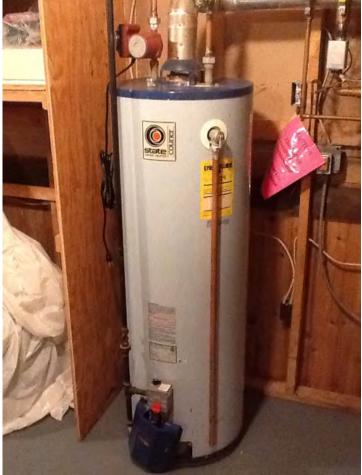
State 50 gallon water.

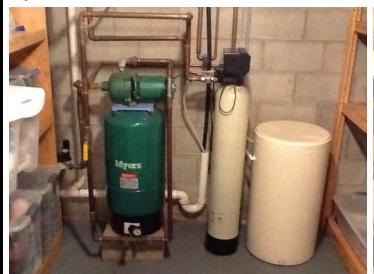
Well pressure tank, pump, and water softener system.

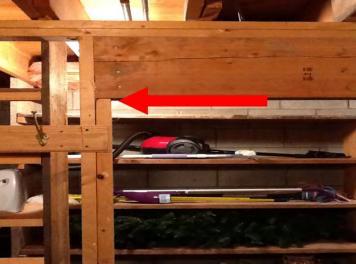
Recommend a bearing point of 3" on both sides of header beam in basement utility room.

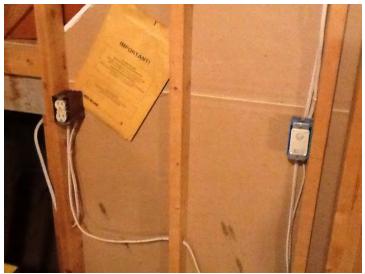
Missing coverplates present a safety hazard.

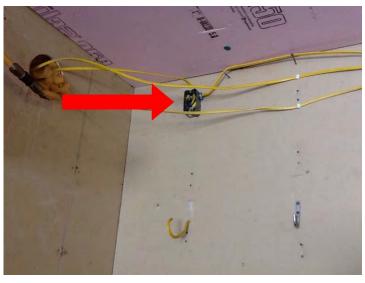
Missing electrical coverplates in garage present a safety hazard.

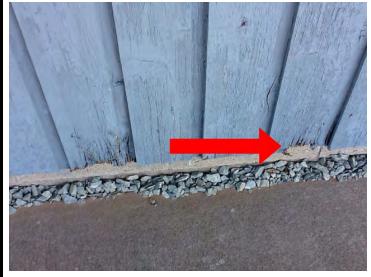
Recommend painting siding to extend useable life.

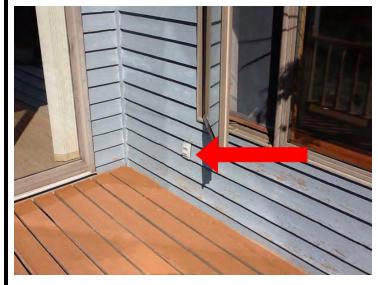
Exterior outlet is missing GFCI protection.
